Howard Community College Facilities Master Plan 2025

Facilities Master Plan

February 2025 Revised: April 2025

Facility Condition Assessment

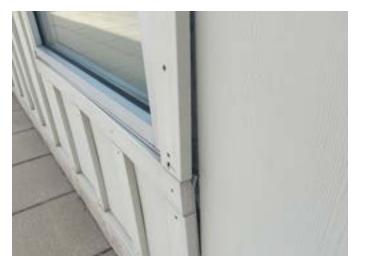
Figure 16 - Loose Window Trim

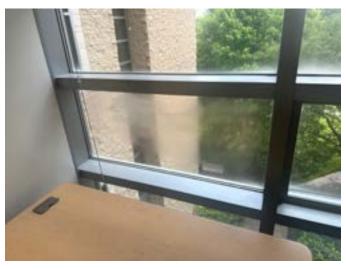
Figure 28 - Fogged Window

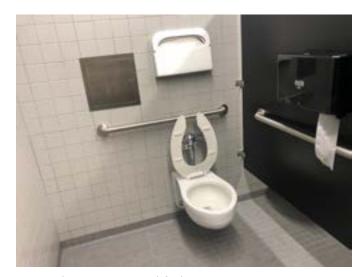
Figure 30 - Missing Vertical Grab Bar

Recommendations include installing vertical grab bars in accessible toilet stalls.

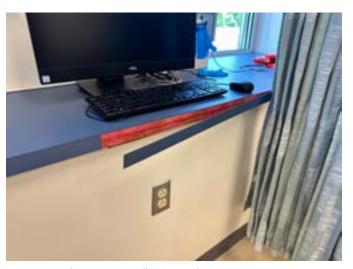
Figure 42 - Countertop Adhesive Failure

Recommendations include drywall repair and paint touch up and/or refreshing classrooms and corridors. Replace damaged or stained ceiling panels when possible. Countertops should be repaired or replaced in areas where the adhesive is failing and delamination has occurred.

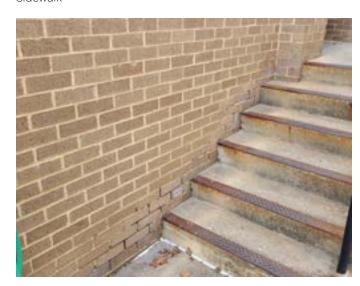
Figure 57 - Mortar Erosion

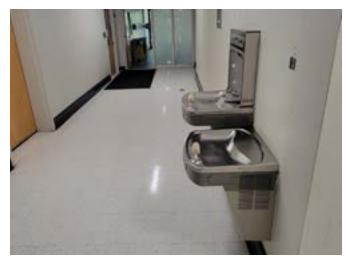
Figure 67 - Drinking Fountains not ADA Compliant

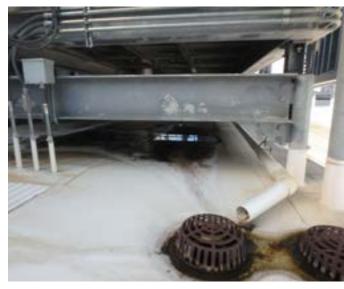
Figure 71 - Ponding on Roof

Recommendations include an analysis of the roof areas where ponding was visible to determine appropriate repairs to avoid future water damage.

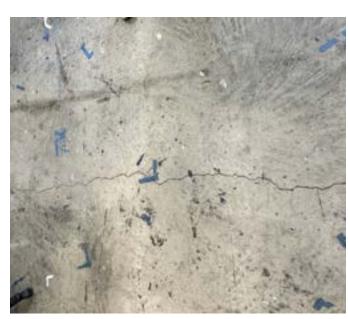
Figure 72 - Crack on Column Line

Recommendations include repairing the crack in the floor to avoid further deterioration.

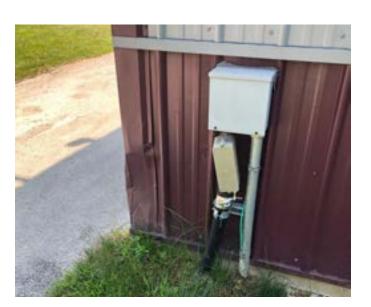
Figure 117 - Dented siding and Damaged Electrical Raceway

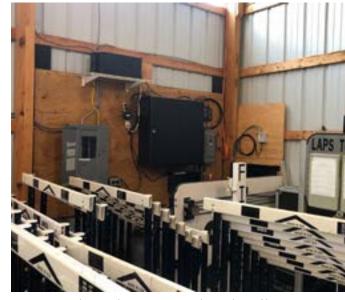
Figure 115 - Electrical Equipment with Working Clearance Violations

Recommendations include moving athletics equipment out of the required clear working space for electrical equipment.

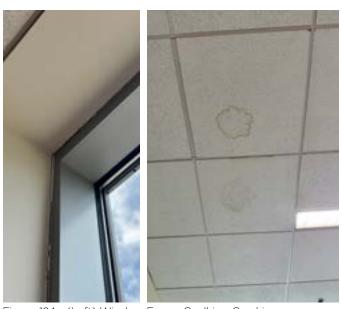
Figure 124 - (Left) Window Frame Caulking Cracking Figure 125 - (Right) Ceiling Tile Damage

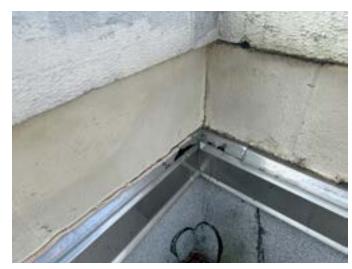
Figure 122 - Cracking Sealant at Parapet Flashing

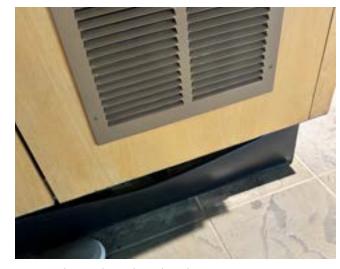
Figure 126 - Vinyl Baseboard Peeling

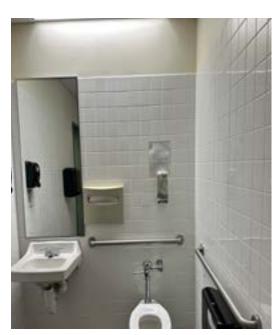
Figure 131 - Vertical Grab Bars Missing

Recommendations include adding vertical grab bars in accessible stalls.

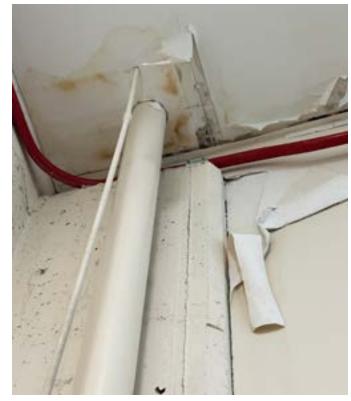
Figure 141 - Water Damage and Peeling Paint

Recommendations include repair and repaint damaged drywall and peeling paint.

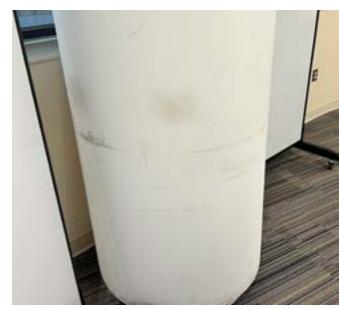
Figure 142 - Example of Scuffed Paint

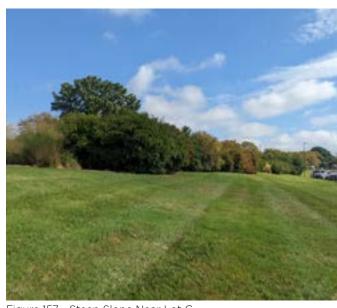
Steep slopes and the associated stream valley and stormwater management pond that bisects the middle of campus create conditions that make ADA accessibility from the north to the south parts of campus a challenge.

Figure 157 - Steep Slope Near Lot C
