Howard Community College Facilities Master Plan 2025

Facilities Master Plan

February 2025 Revised: April 2025

Facility Condition Assessment

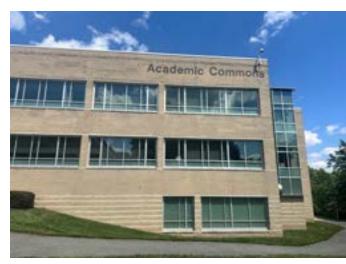
Figure 3 - Building Exterior

Most of the exterior envelope of the building consists of architectural Concrete Masonry Units (CMU). The building exterior ranges from being in mostly good condition with some areas in fair condition.

Some CMU walls had areas where the grout has started to deteriorate. Other areas showed signs of rusting or minor staining from mildew and moisture.

Recommendations include repair or replacement of deteriorating grout where needed and cleaning of rust or mildew stains.

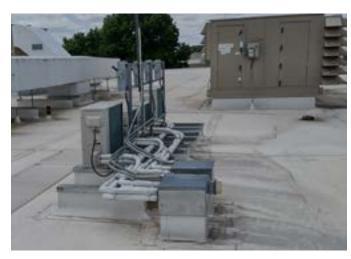
Figure 11 - Rooftop Condensing Units

AHUs are primarily located on the roof as are condensing units. The building was renovated in 2019 and HVAC equipment, distribution piping and ductwork systems are in good condition.

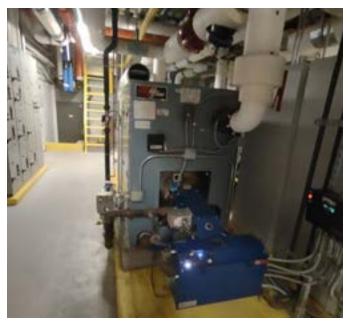
Figure 19 - Dual Fuel Boiler

The central chiller and boiler plant in the Clark Library main utility room also serves the Academic Commons, Howard Hall, and McCuan Hall buildings. The plant consists of two dual fuel gas/oil boilers, four Lochinvar modular gas fired boilers, two chillers, and two cooling towers located on grade adjacent to the building. Central plant equipment was installed in 2012 and is in good condition, except the four Lochinvar boilers that were installed over 20 years ago, which are in fair condition. AHUs and split systems are located on the roof and throughout the building and are approximately 20 to 25 years old. While well maintained, they are approaching the end of their expected life and replacement, or refurbishment should be considered. The distribution system consists of ducted supply to VAV boxes

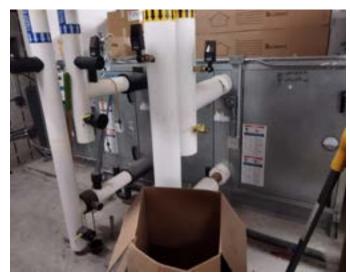
Figure 22 - AHUs

and return air plenums. The distribution system is in good condition, although the VAV boxes are approaching the end of their expected life.

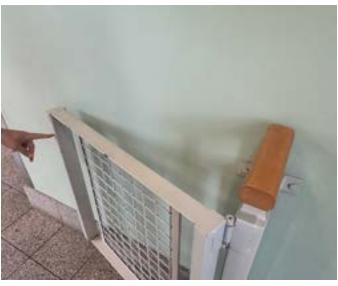
Figure 29 - Metal Gate Swing

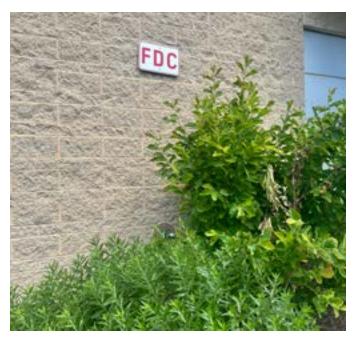
Figure 31 - FDC Covered by Vegetation

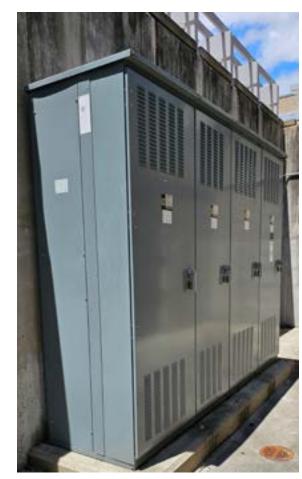
Figure 85 - Electrical Switch

Currently, there is no Arc Flash labeling of equipment in the building and some working clearance violations were observed in electric rooms.

Recommendations include addressing the Arc Flash labeling of equipment as soon as practical and replacing/ upgrading fluorescent light fixtures with LED fixtures as funding permits. In addition, items being stored in dedicated electrical spaces should be removed to eliminate clearance violations.

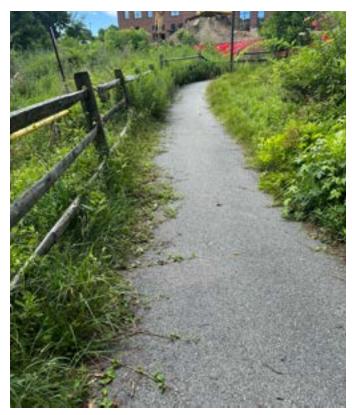
The understories of many forest edges contain invasive species including multi-flora rose, poison ivy, and honeysuckle. Selective cutting and pulling of invasive species as suggested by the 2015 Facilities Master Plan has begun to allow some natural regeneration of the forest floor. Additionally, some replanting of native species has begun in selected areas.

Figure 153 - Invasive Species in Understories
